# Georgia Living Shoreline Solutions

# Georgia Living Shoreline Locations

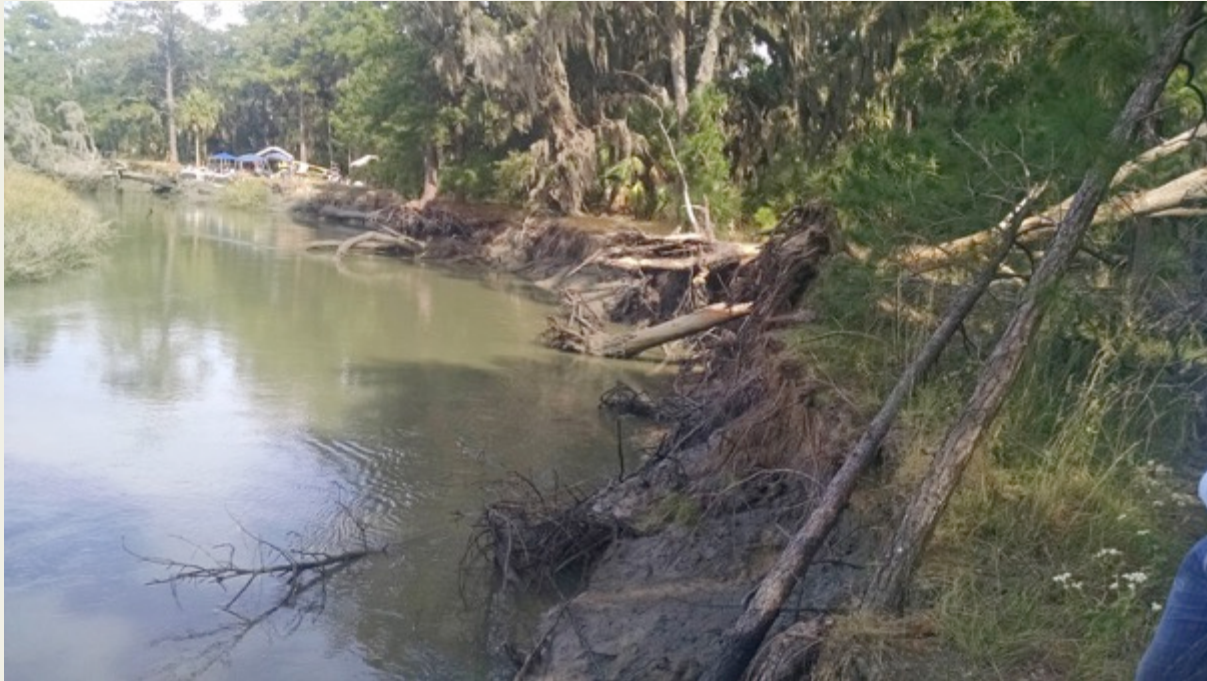
# St. Catherine's Island

- Typical erosion pattern along salt marsh creek
- Usually outside curve of creek
- High tides affect adjacent bluffs
- Slopes near vertical
- Usual need for shoreline design is protection

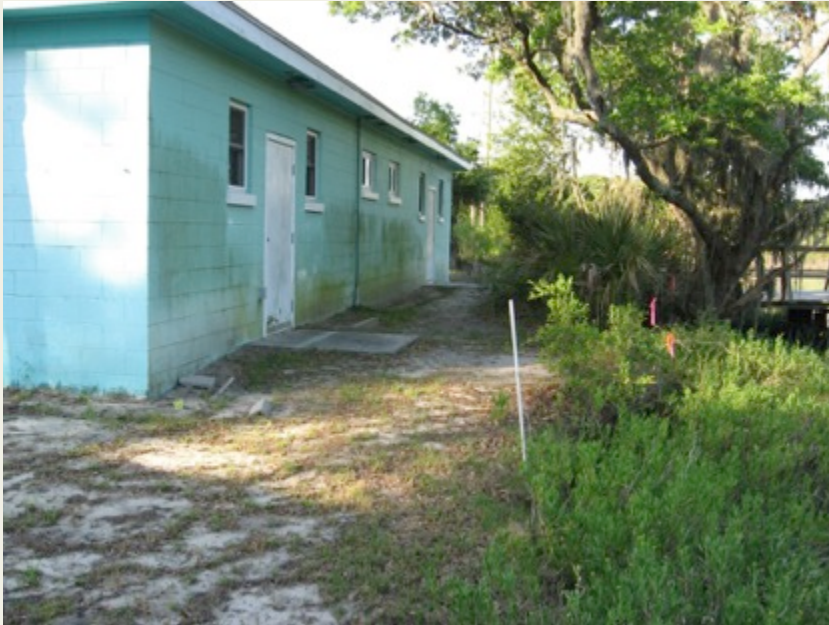
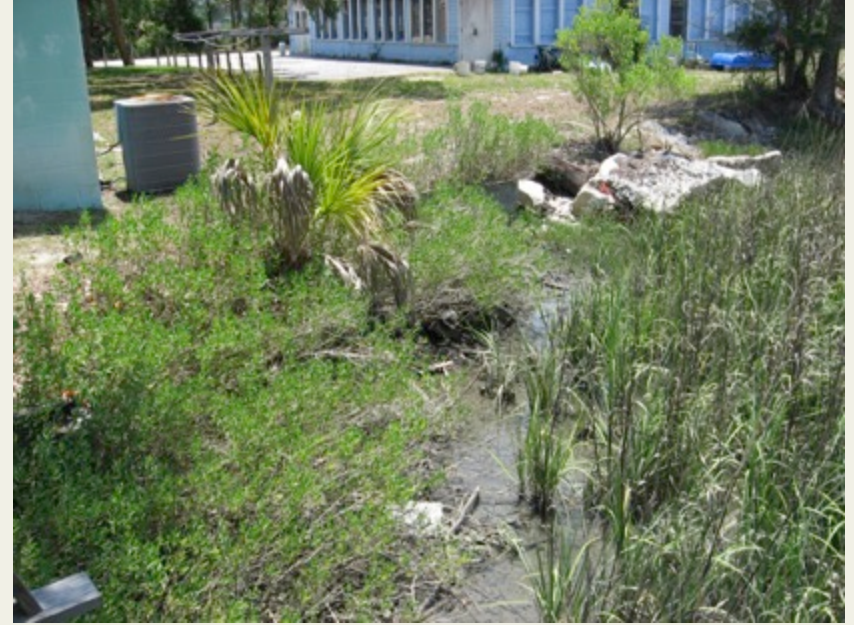
# Burton 4H on Tybee Island

- Structures in jeopardy from eroding creek banks
- Tybee 4H center, erosion of approximately 3 feet per year

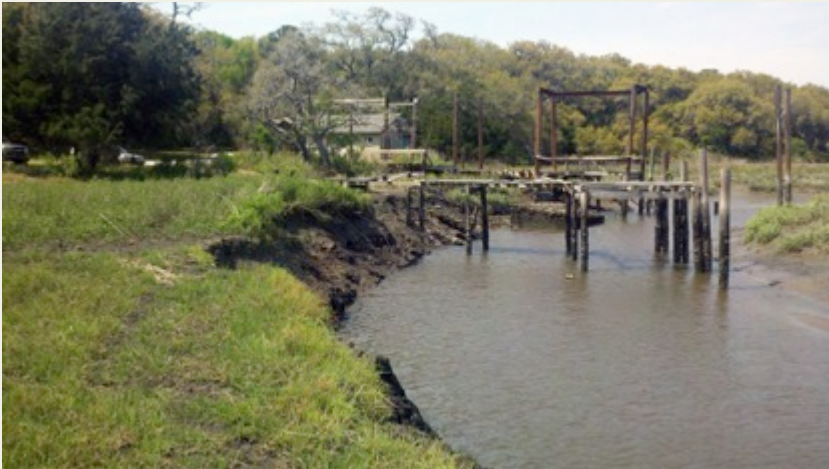
Pre-Project Conditions

- Salt Marsh along Lawrence Creek
- Actively eroding creek bank
- Outside edge of curve, near 1:1 slopes

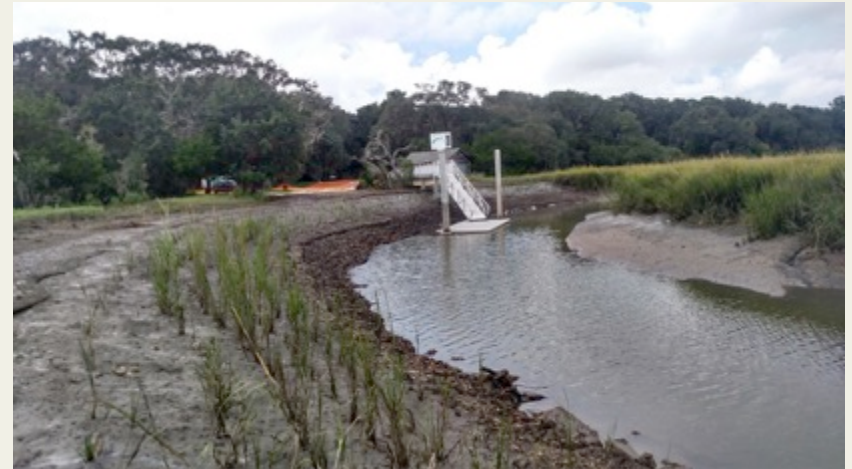
Post-Project Conditions

- Bottom slope 1.5:1, top slope 3:1
- Spartina & Oxeye above oyster bags
- Toe protection under water

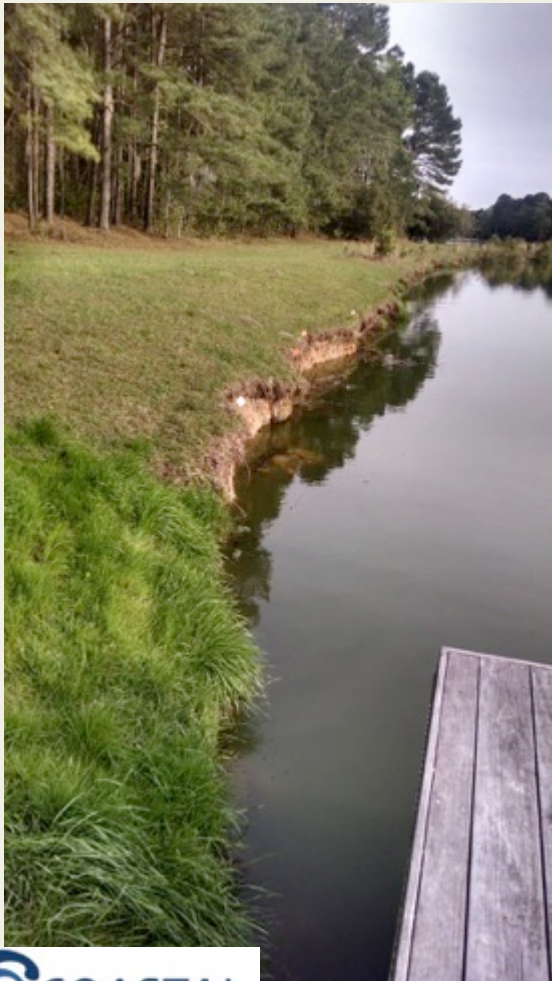
- Fresh water lake in Richmond Hill, GA
- ← Problem
- Soils happy with less slope
- Erosion caused by wave action
- Turf grass to shoreline

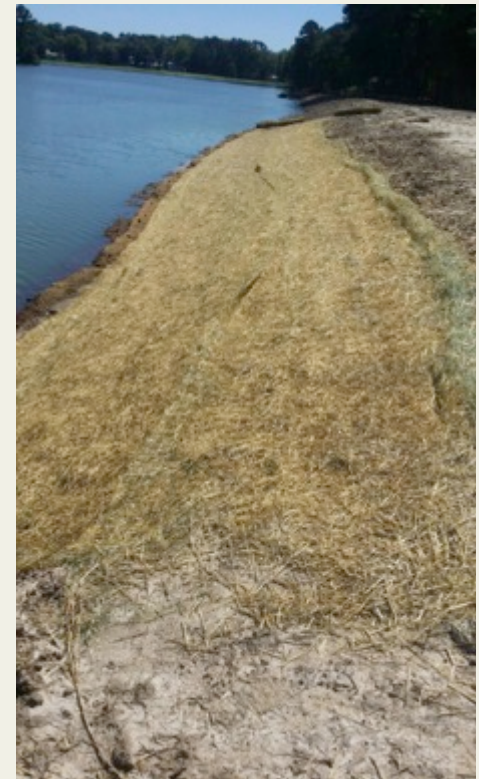
Solution →

- Flatten slopes
- Provide temporary protection
- Plant with native aquatics & shoreline plants to establish vigorous root growth
