# The Costs of Shoreline Stabilization

# Installation Cost Comparisons

## Bank Stabilization Cost Estimates - Little St Simons Island, GA -

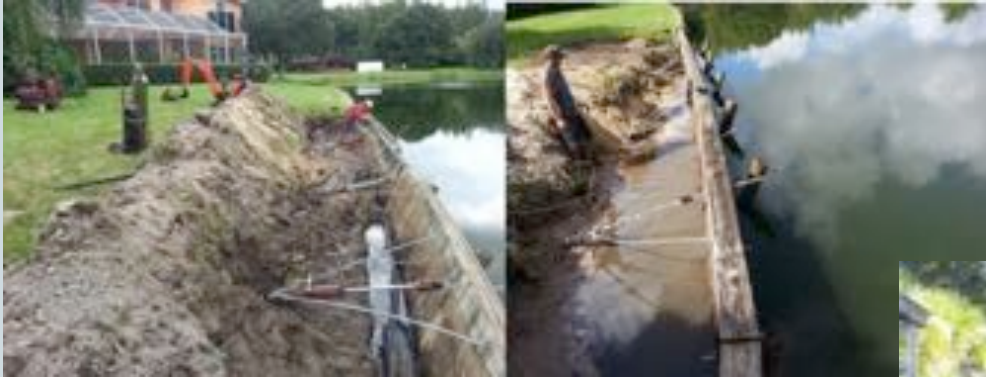
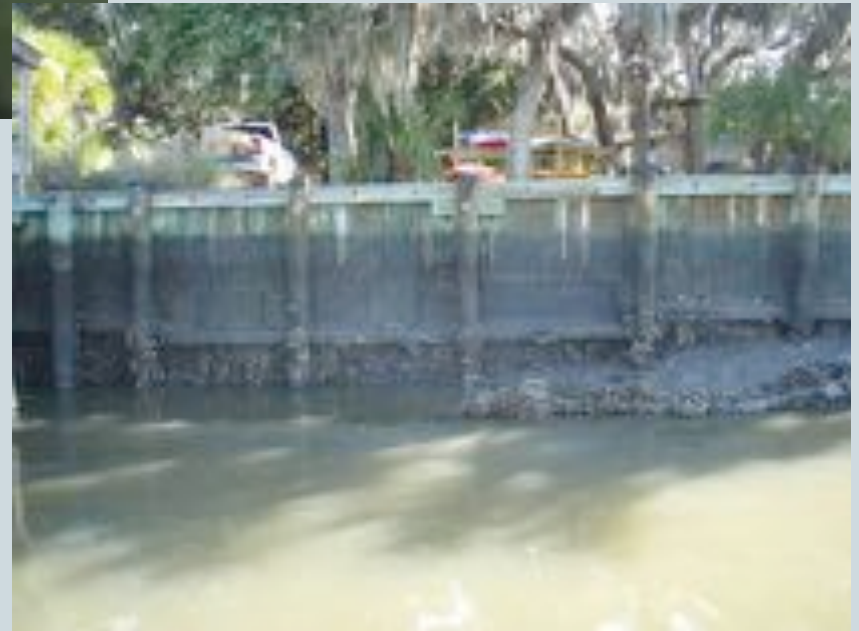
## **Little St Simon's Island Bulkhead Repair**

2013 Quoted (with other work): \$5134

Length = 37.5'

2016 Estimate (without other work): \$7600-

\$8600

Length = 37.5 LF

LF Price: \$202 - \$229

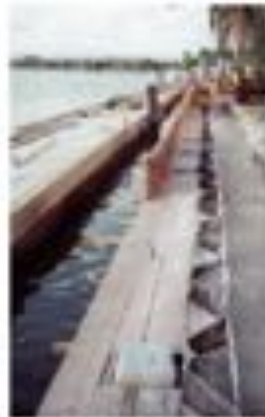
Replacement steel sheet pile bulkhead under construction, Bahia Acahuacal Yachting Center, Ft. Lauderdale, Florida

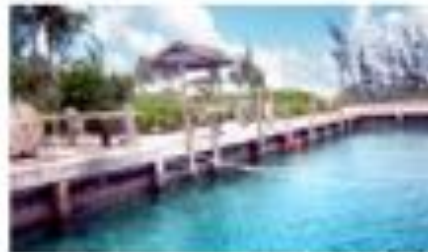
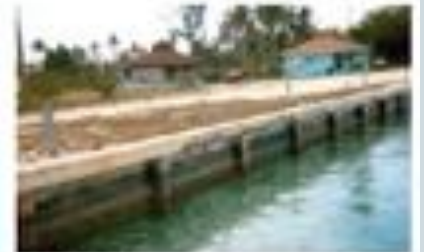
Two examples of typical concrete bulkheads (Florida, Bahamas)

Pilecap and clear piling configurations provide a service life of 10+ years if correct mix design and proper marine structural design implemented. Shear piling can be difficult to install in hard substrates, and concrete pile cap/walls can be subject to undermining.

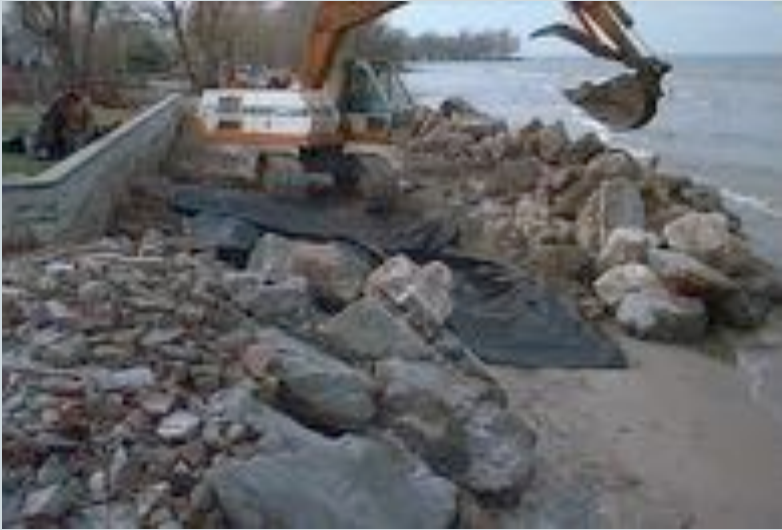
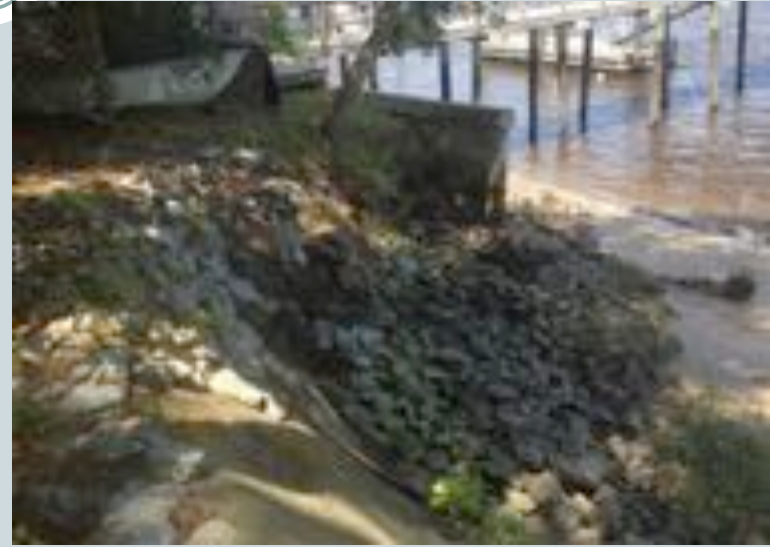
**2016 Repair Estimate :**

LF Price: \$100 - \$250

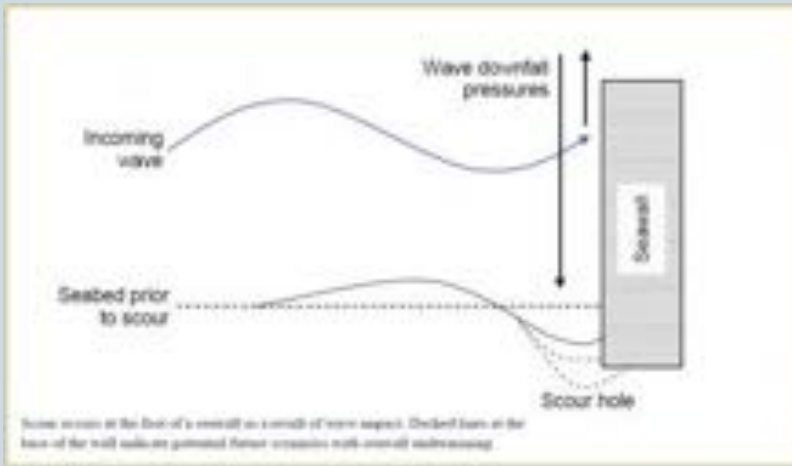
Figure 2: Schematic cross-section illustrating seawall scour (Source: Linham and Nicholls, 2010)

- Smooth, vertical seawalls are the least effective at dissipating wave energy; instead, the structures reflect wave energy seawards. Reflection creates turbulence, capable of suspending sediments (Bush et al., 2004)
- Scour at the foot of a seawall is a particular problem with vertical seawall designs. As a result, seawall maintenance costs can be high (Pilarczyk, 1990a).
- Although seawalls prevent erosion of protected shorelines, where the seawall ends, the coast remains free to respond to natural conditions. This means that undefended areas adjacent to the wall could move inland causing a stepped appearance to the coast (French, 2001). This flanking effect can cause undermining and instability of the wall in extreme cases.

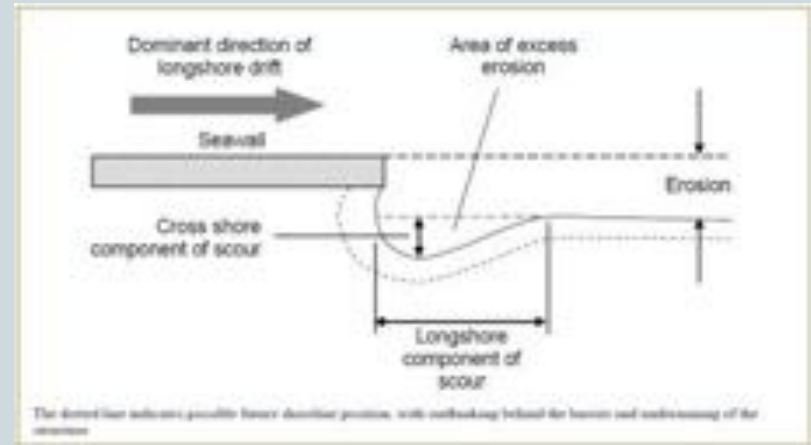
Figure 3: A seawall as viewed from above, showing typical end effects associated with the structure (Source: Adapted from McDougal et al., 1987)

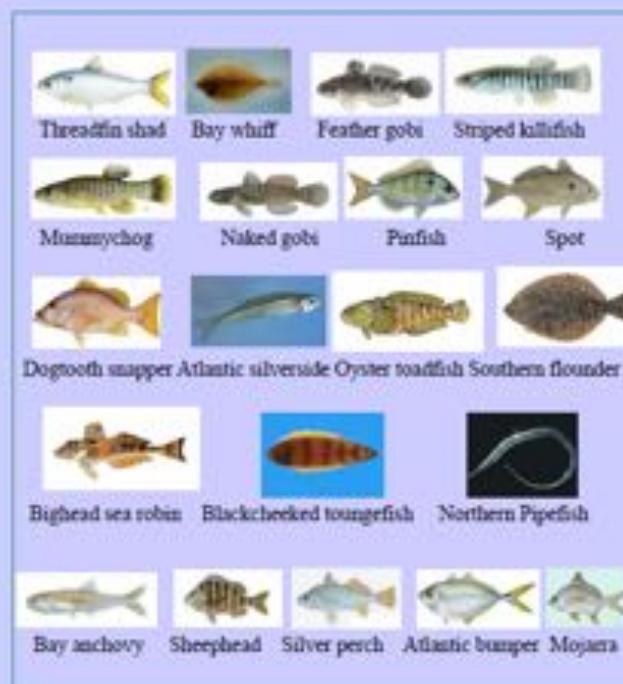
**Figure 7.** Pictorial display of the finfish diversity captured through-out the first two sample seasons (pre- and post- construction) at the LSSI site. These photos represent, in all cases the adult phase of each species.

Preliminary results at LSSI site include a 100% increase in finfish species diversity within the LS area after only 6 months of completion (**Table 1, Figure 7**). Notably, the capture of two juvenile individuals within the demersal (bottom dwelling) species of concern stocks (Dogtooth Snapper *Lutjanus jocu*; snapper-grouper complex) were within the post-construction fish assemblage. Post-construction survival of planted vegetation approached 95% at six months with losses attributed to deer browsing. Significant increases in both bay anchovies (**Table 1**) and grass shrimp (Bliss et al., 2014) were noted after construction of the Living Shoreline. Oyster recruitment (cementation) onto the shoreline across all tidal zones achieved densities between 44-108/m<sup>2</sup> by the end of the first season of available spat recruitment (April- October, 2013). Slight erosion of upland soils occurred directly following construction due a combination of the instability of soils (large grained sands) and the lack of extensive root development by the newly planted (and volunteer) vegetation.
